# Manhole Inspection Summary

Manhole # S37E\_\_057MH

Insp Date: **10/20/08 1:41 PM**

**Location** Address: **10 holliday st**

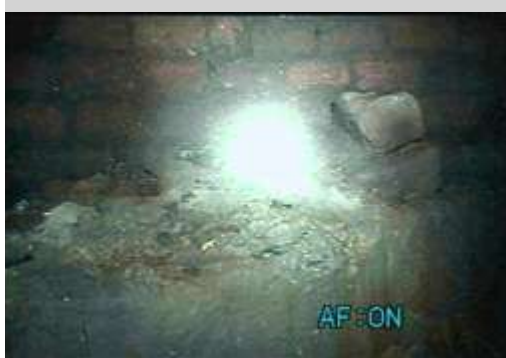
MISCELLANEOUS

bench debris

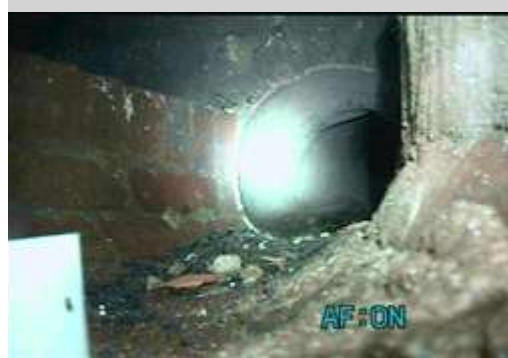
MISCELLANEOUS

channel debris

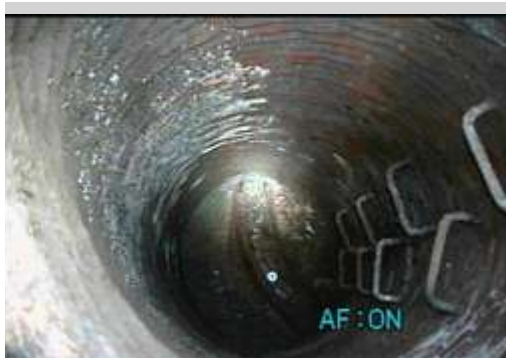
Defect 4

Infiltration: ☐ None ☐ Joint ☐ Cracks ☐ Mortar ☐ Roots ☒ **Wall**

signs of Corbel and barrel infiltration

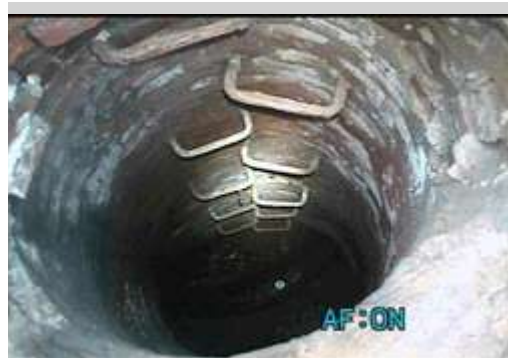
Defect 3

**Steps** Count: **10** Missing: **0** ☒ **Corroded**

cor. steps

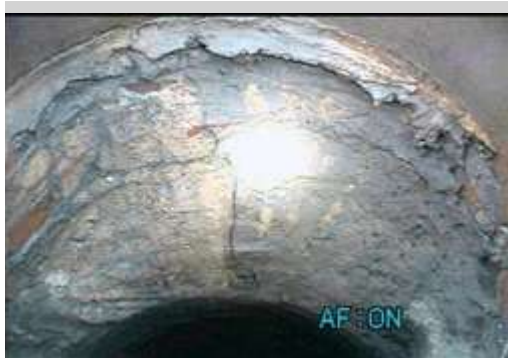
Defect 2

Condition: ☐ Sound ☒ **Cracked** ☐ Root Intrusion ☐ Loose Brick ☐ Deteriorated

crack in corbel

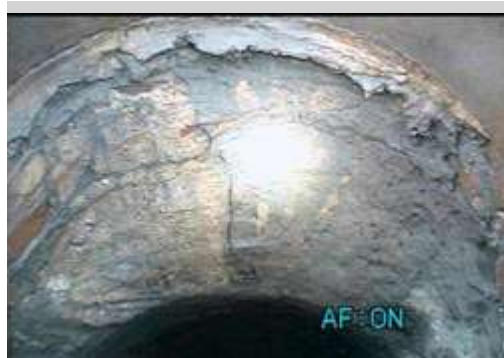
Defect 1

Condition: ☐ Sound ☒ **Cracked** ☐ Root Intrusion ☐ Loose Brick ☒ **Deteriorated**

crack and deteriorated frame adj
